June 2016

Dam Rehabilitation Fact Sheet

Lake Pelham, Mountain Run Watershed

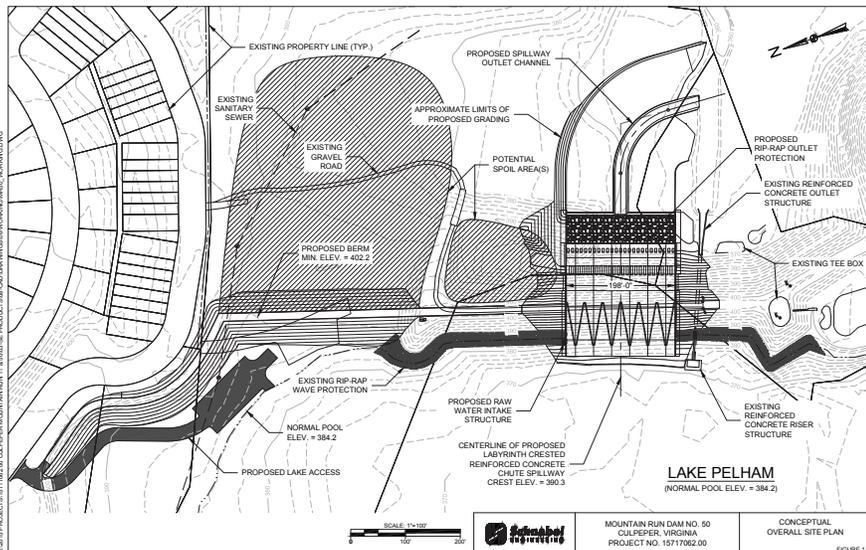
The plan view drawing below outlines the proposed solution to the auxiliary spillway problem.

The plan includes the following rehabilitation activities:

- Installing a 198-foot wide, 6-cycle structural concrete labyrinth weir auxiliary spillway over the embankment
- Installing an earthen berm across the existing auxiliary spillway
- Installing a stilling basin and rip-rap outlet protection below the dam
- Upgrading the water intake structure

Project activity will not affect existing water supply storage, recreational uses or current levels of flood protection downstream.

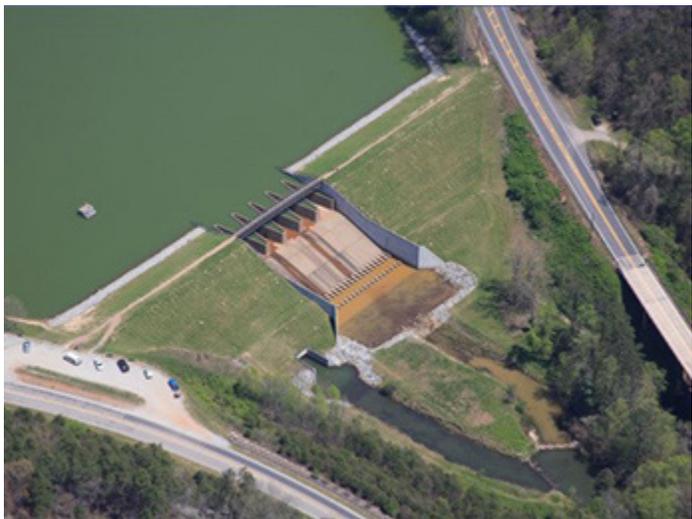
The photo above is an aerial view of a typical labyrinth weir. The graphic below provides a closer look at how this enhancement to a spillway helps to control rising flood waters.
