# Dam Rehabilitation Fact Sheet

## Mountain Run Lake, Mountain Run Watershed

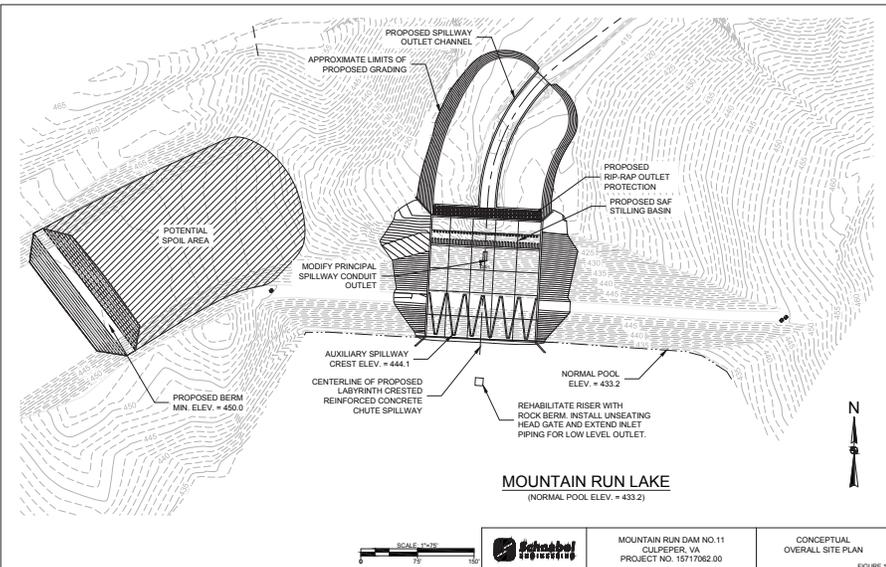
The plan view drawing below outlines the proposed solution to the auxiliary spillway problem.

The plan includes the following rehabilitation activities:

- Installing a 144-foot wide, 6-cycle structural concrete labyrinth weir auxiliary spillway over the embankment
- Installing an earthen berm across the existing auxiliary spillway
- Installing a stilling basin and rip-rap outlet protection below the dam
- Upgrading the principal spillway riser to meet seismic criteria through the installation of about 5.5 feet of granular rock fill placed above and around the periphery of the existing riser footer

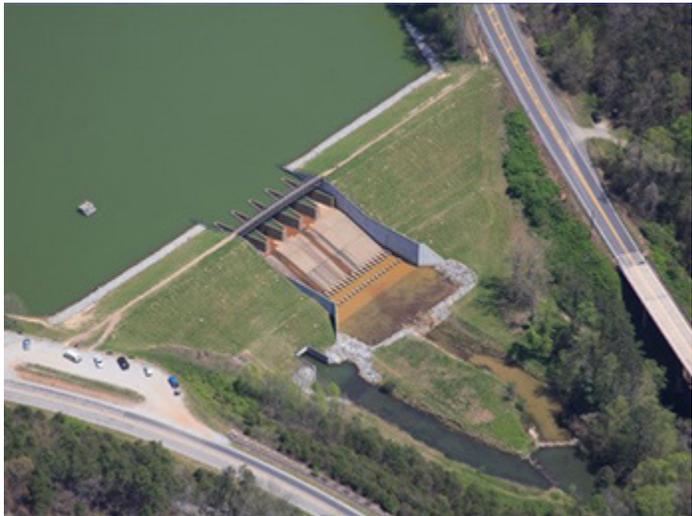
The photo above is an aerial view of a typical labyrinth weir. The graphic below provides a closer look at how this enhancement to a spillway helps to control rising flood waters.
