**Draft Supplemental Watershed Work Plan Number 4
and Environmental Assessment**

**For the Rehabilitation of Structure No. 9 (Rock Mill Dam)
in the Upper Hocking Watershed
Fairfield County, Ohio**

Prepared By:
U.S. Department of Agriculture
Natural Resources Conservation Service

December 2011

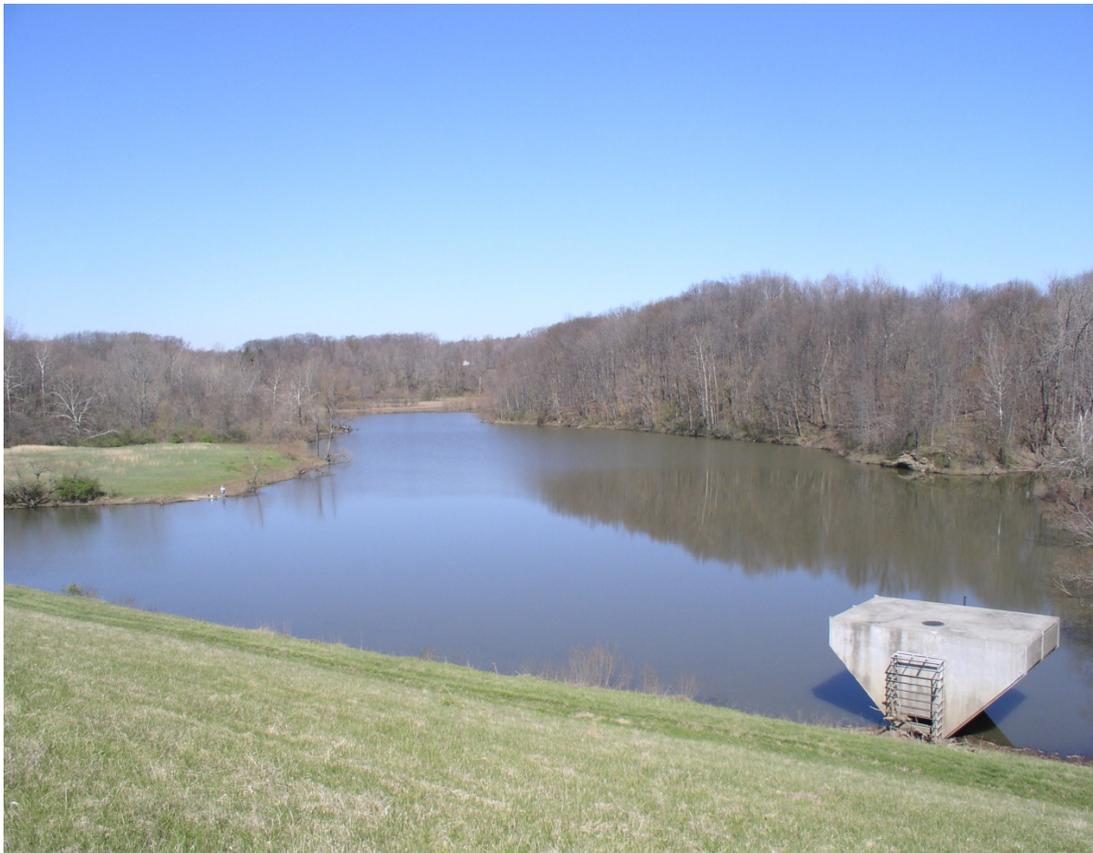
Figure 2. – Looking upstream from dam at lake and riser

Upper Hocking Structure 9 (Rock Mill Dam) is located in Fairfield County, approximately three miles west of Lancaster, Ohio. The lake has a drainage area of 4,583 acres (7.16 square miles) and is located on the headwaters of the Hocking River. The Hocking River flows southeast through Fairfield County, then through Hocking and Athens Counties and into the Ohio River near Hockingport, Ohio. The lake and surrounding property is owned and managed by Ohio Department of Natural Resources as a Rock Mill Lake State Wildlife Area with public boat access from Mt. Zion Road. (Figure 1) Pictures of part of the lake, dam, riser, and outlet channel can be seen in Figures 2, 3, and 4.

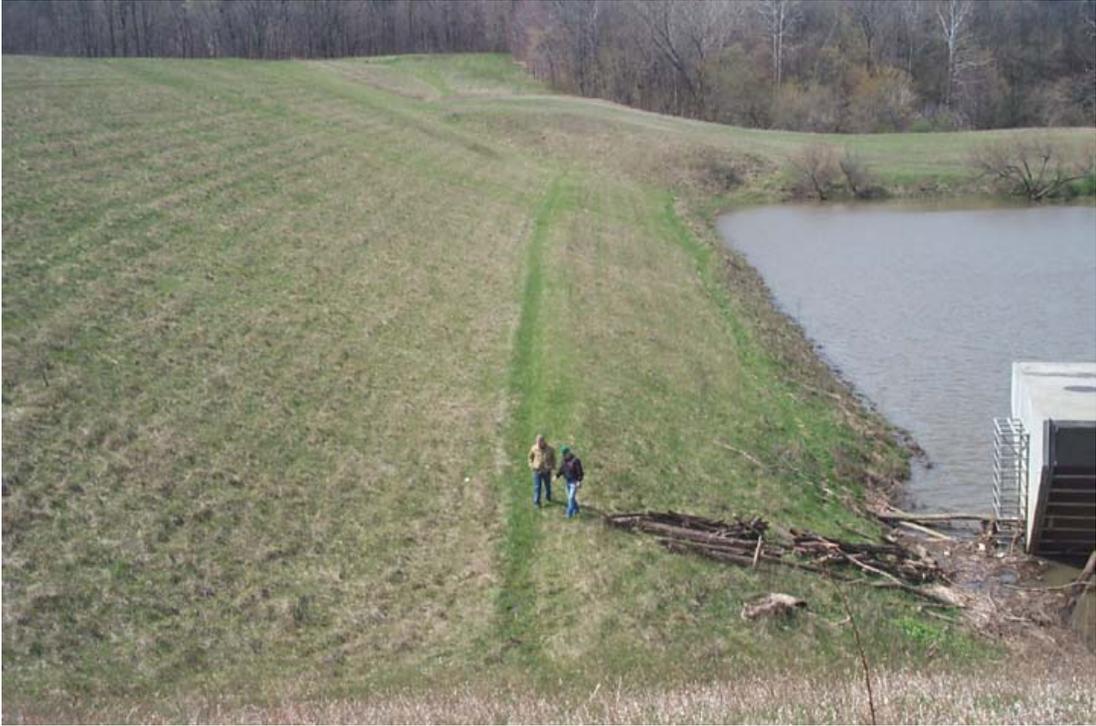
Figure 3. Upstream slope of Rock Mill Dam.

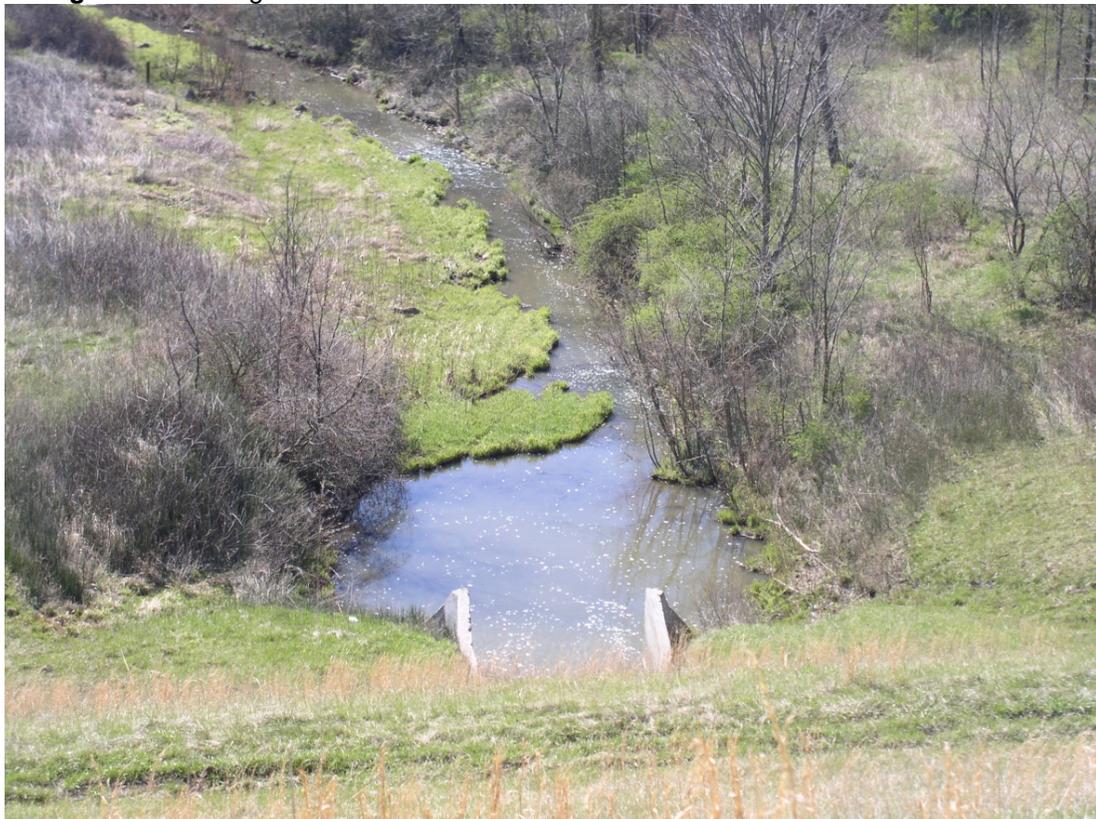
Figure 4. Looking downstream from dam at outlet structure and outlet channel

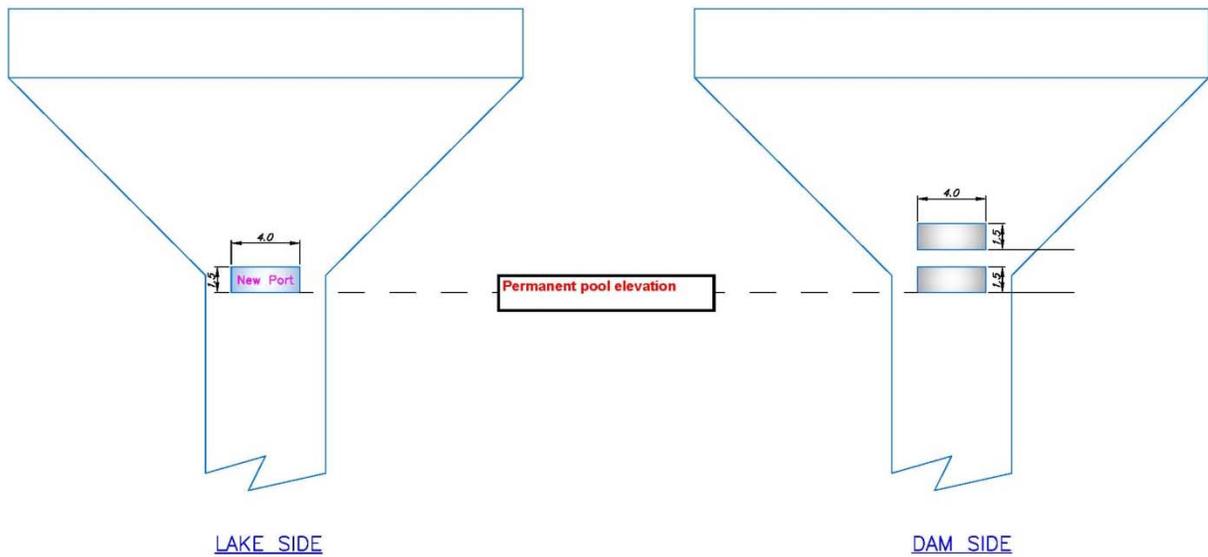
Figure 5. Riser low inlet proposed modification

The surface of the concrete on the concrete riser and outlet structure would be repaired and sealed. The sponsors plan to modify the riser to increase low flow through the principle spillway. Part of Mt. Zion Road located in the flood pool of this existing dam experiences frequent flooding. The low spot in this road begins to go under water when rain exceeds 1.6 inches in 24 hours (less than a 1-yr return period). The riser would be modified by cutting an additional low inlet (side port) into lake side of the riser. This new opening would be 1.5 feet high by 4 feet long and is identical to the size of the existing two openings (Figure 4). This would reduce the frequency of flooding of the road and provide more time before the road floods for the same rain event.

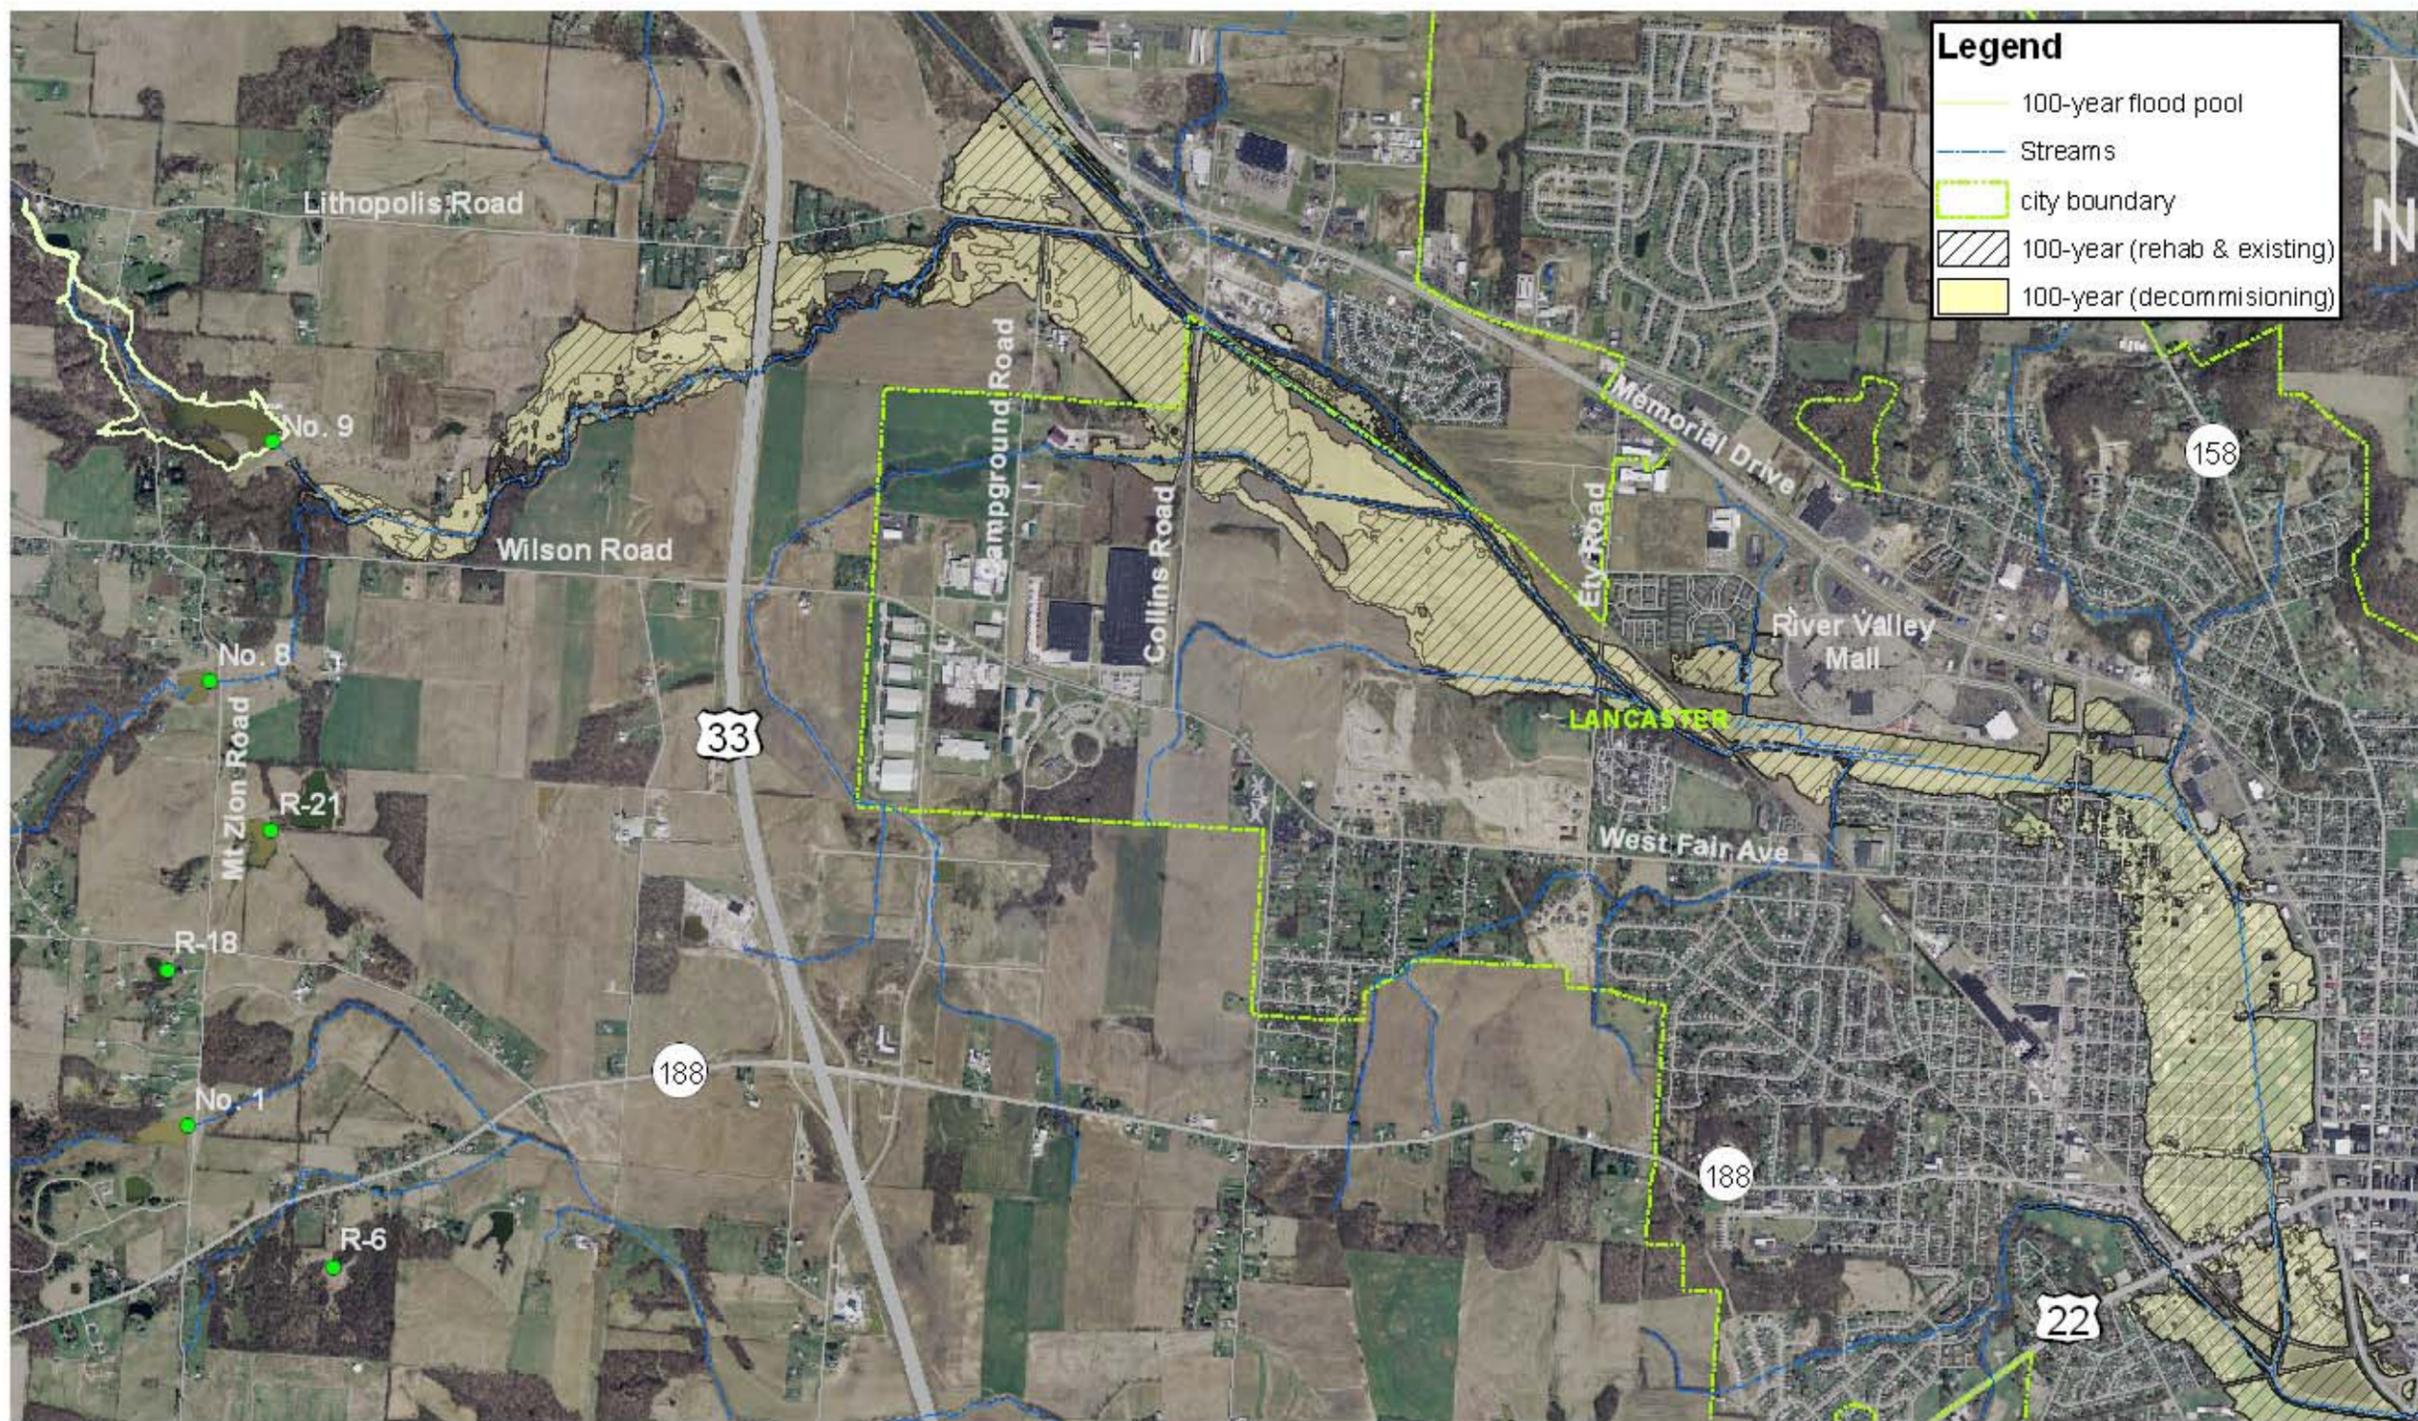
Appendix C. 100-Year Flood Map
 Upper Hocking 9 100-year floodplain

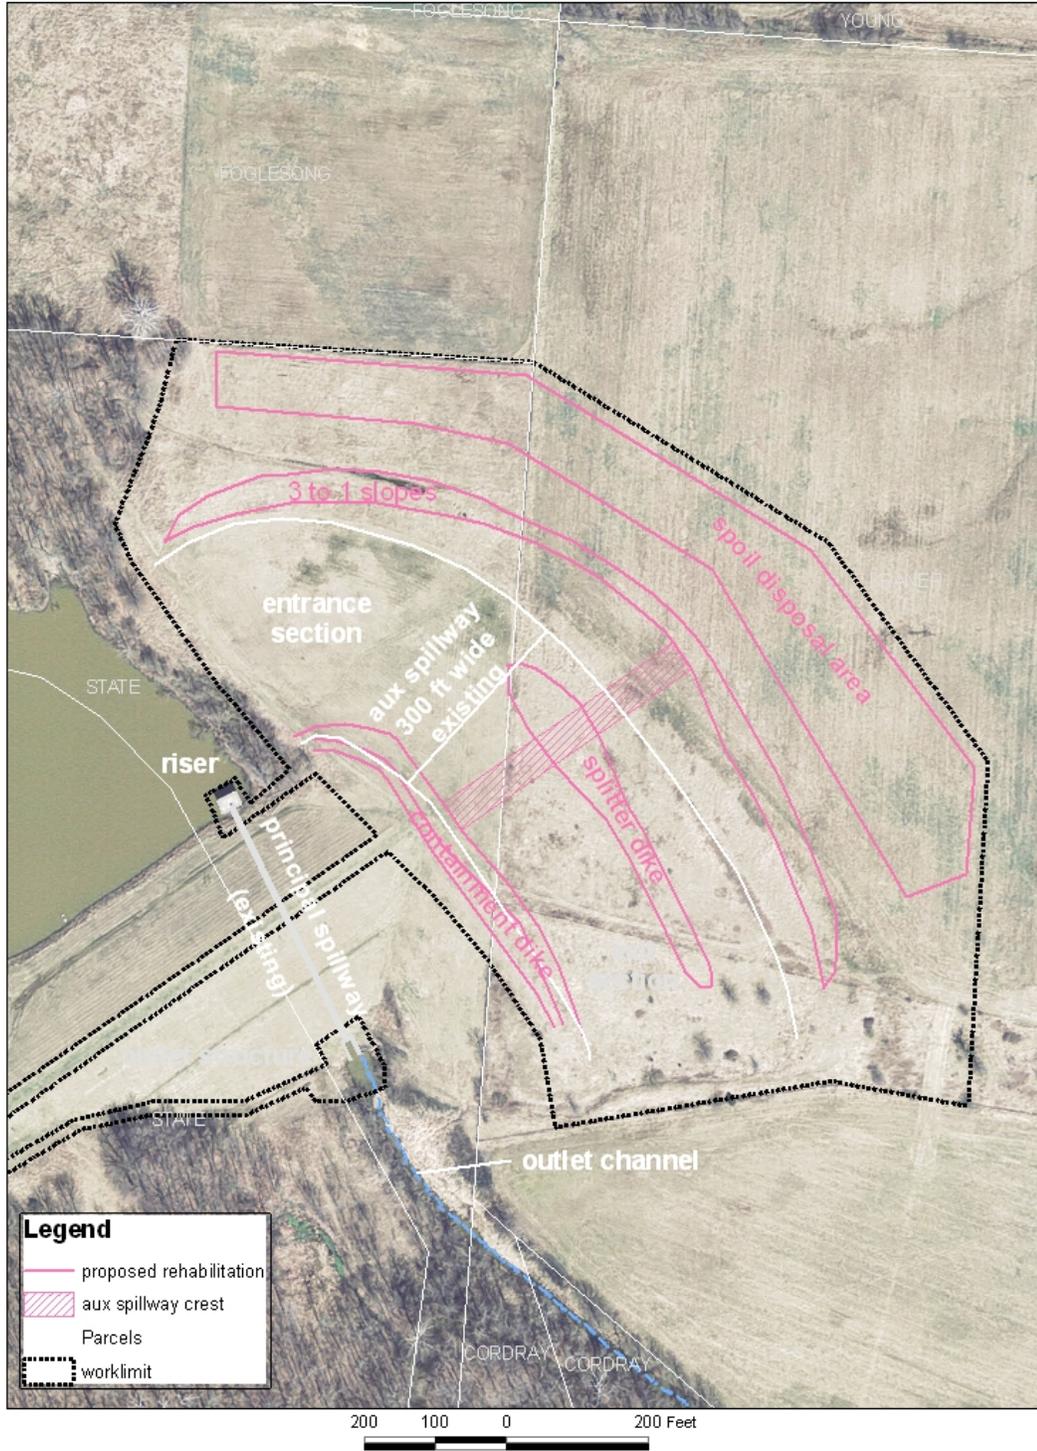
Upper Hocking 9 - Rehabilitation General Layout

The preferred alternative is to rehabilitate Rock Mill Dam to meet current design, performance and safety criteria for a high hazard dam. Rehabilitation would include widening the auxiliary spillway from 300 to 320 feet, and lowering the crest of the auxiliary spillway three feet. A splitter dike would be constructed along the centerline of the auxiliary spillway to divide spillway flows into two 160 foot wide bays. The auxiliary spillway would be protected from potential erosion by replacing poor existing surface material with clay and compact in-place. The end of the dam at the auxiliary spillway would be raised, along with the containment dike, to prevent the probable maximum flood from overtopping the dam. Excess excavated material would be placed above the auxiliary spillway outside the flood

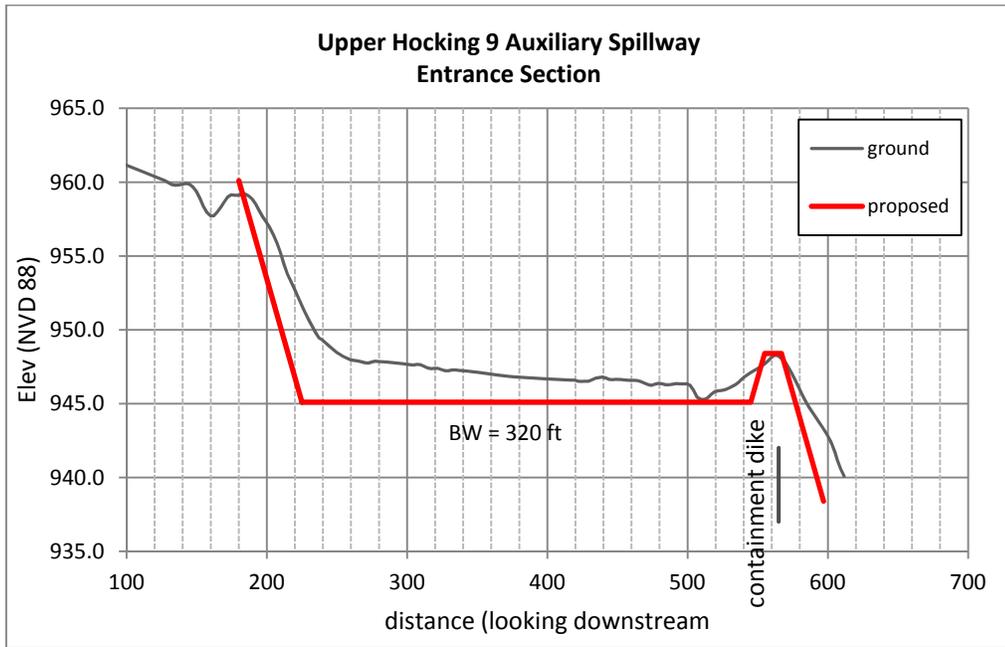
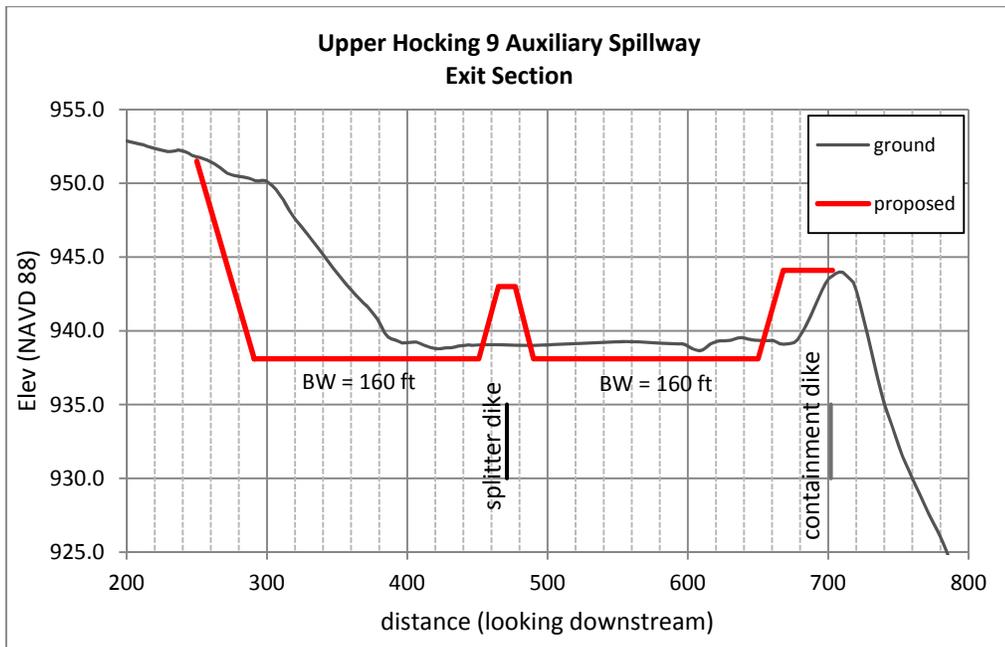
Appendix C. Typical Auxiliary Spillway Rehabilitation Cross Sections

2. Rehabilitation of Structure 9 – This alternative would consist of widening the auxiliary spillway from 300 feet to 320 feet, and lowering the crest three feet to increase auxiliary spillway discharge. The end of the dam at the auxiliary spillway would be raised, along with the containment dike, to prevent the probable maximum flood from overtopping the dam. Poor materials in the auxiliary spillway would be replaced to protect the auxiliary spillway from excessive erosion. The concrete surfaces of the riser and outlet structure would be repaired and sealed. An additional side inlet port to the riser would be a design feature added to increase low flow capacity to reduce flooding duration and frequency on Mt. Zion Road located in the flood pool. A lake level gage would also be installed to provide emergency responders and local residence warning before Mt Zion Road would be submerged. All disturbed areas would be vegetated for erosion and sediment control. These measures would allow the dam to continue to provide flood protection for 100 more years.

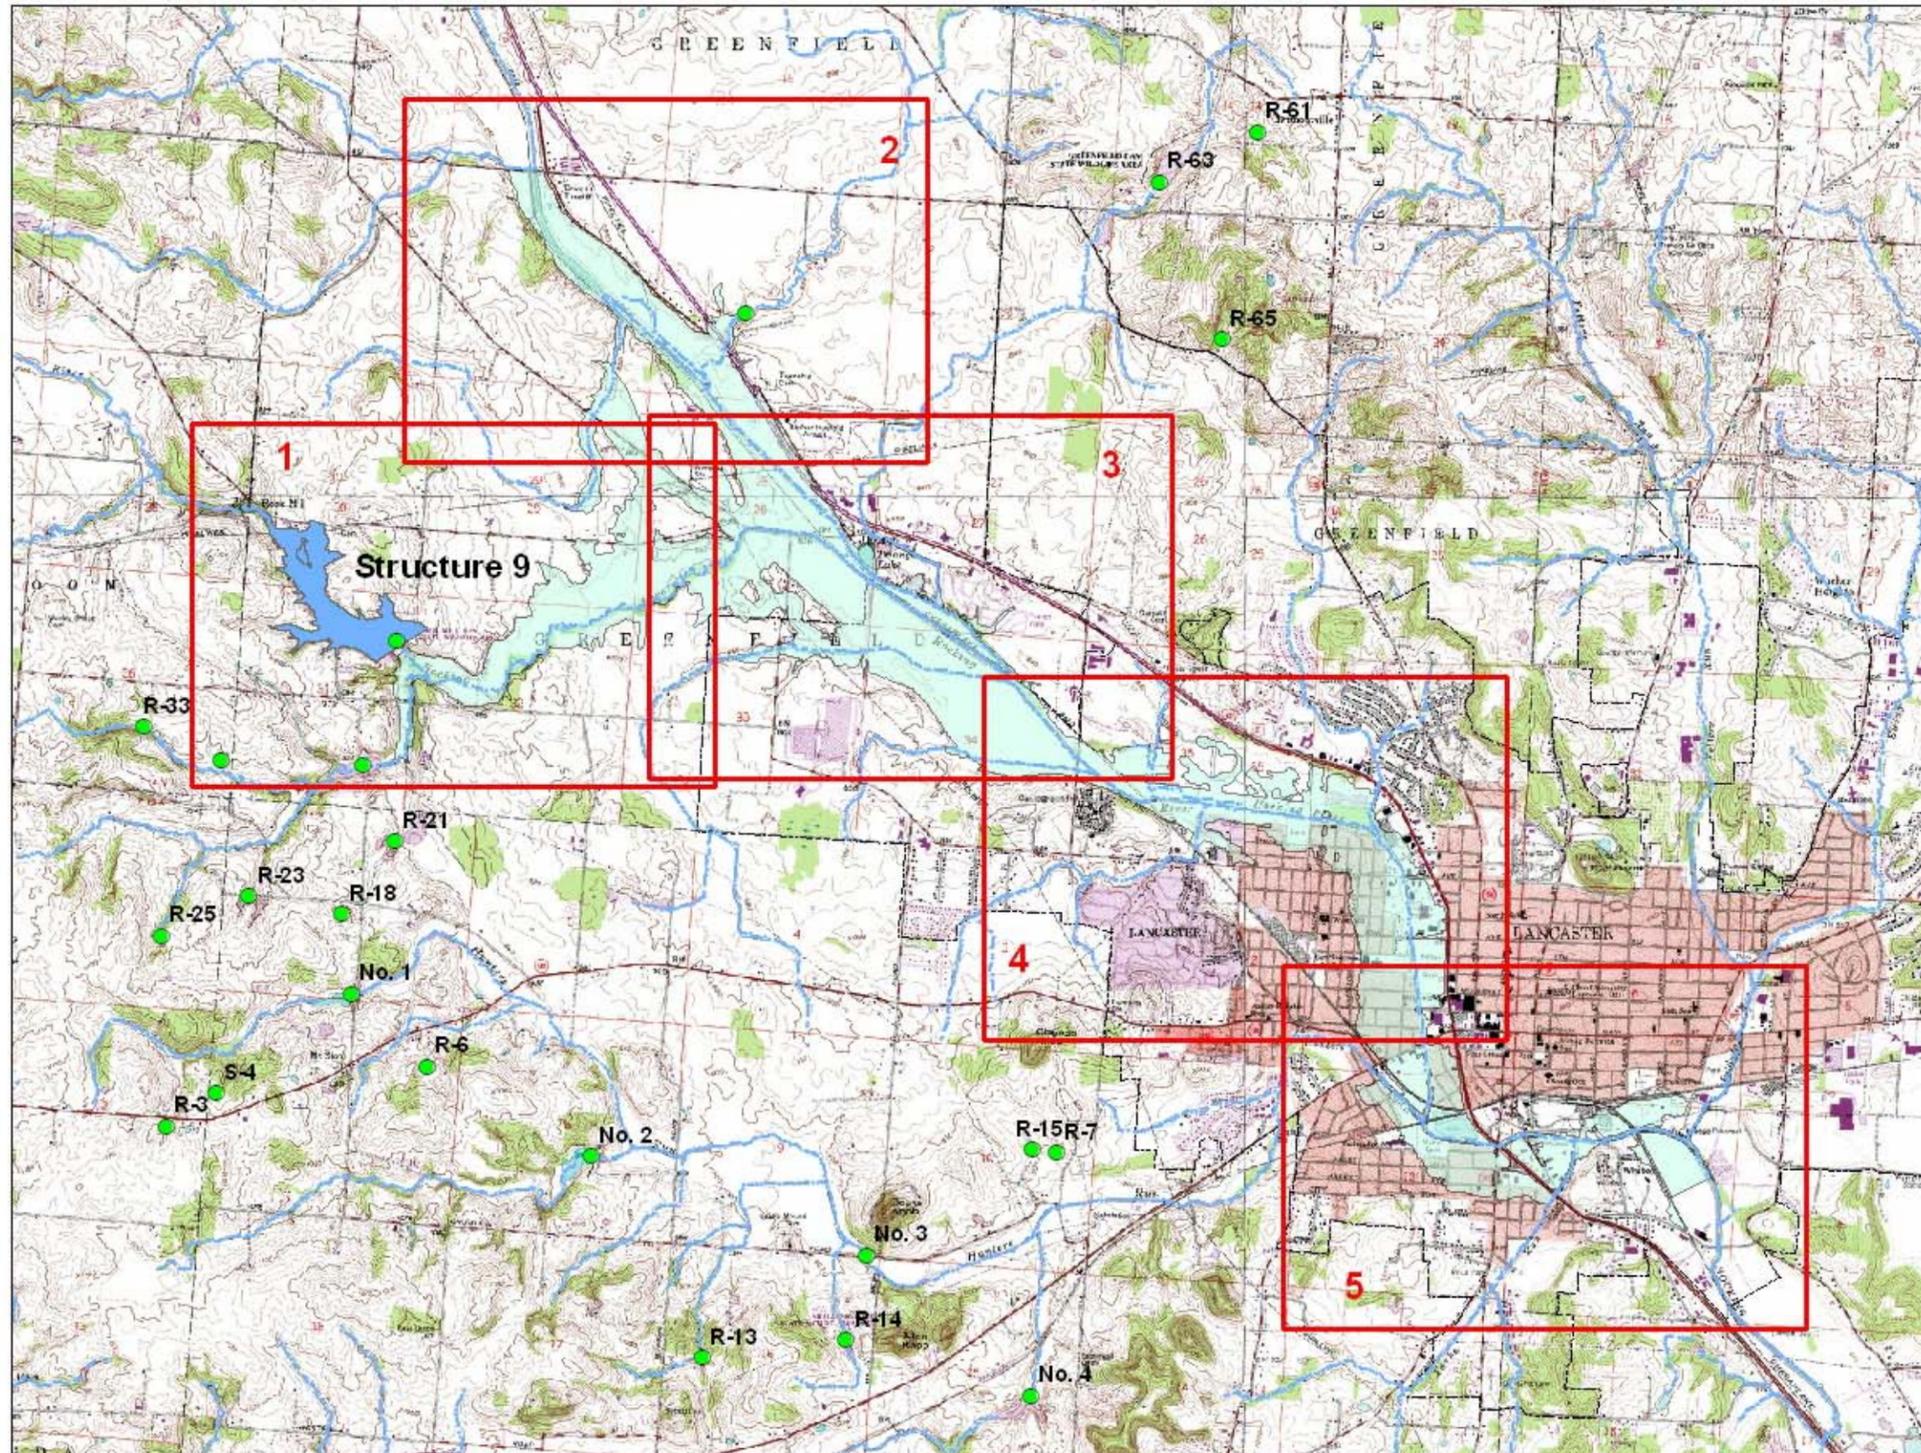
Upper Hocking
Structure 9
Breach Inundation Map

There are at least five houses and several farm buildings in the breach inundation area within two miles downstream of the dam. The water would likely be over three feet deep inside two of these houses during a breach of the dam. The River Valley Mall is located just within the breach inundation area five miles downstream of the dam. Between the mall and US highway 22 located six miles downstream there are over 200 houses and 50 commercial buildings in the City of Lancaster that are within the breach inundation area. Ten bridges cross the downstream floodplain between the dam and US 22 in Lancaster including two major highways, several railroad bridges, county roads, and city streets. If the dam were to fail, public services and utilities would be disrupted as well as damages would likely occur to at least two city parks and one Junior High School. Failure of Rock Mill dam would eliminate this 11 acre public access fish and wildlife lake that is managed by ODNR.
