**FINAL**  
**Supplemental Watershed Plan No. 5 and Environmental Assessment**  
**for the**  
**Rehabilitation of Floodwater Retarding Structure No. 50**  
**(Lake Pelham)**  
**of the Mountain Run Watershed**  
**Culpeper County, Virginia**

**Supplemental Watershed Plan No. 5 & Environmental Assessment**  
**for the**  
**Rehabilitation of Floodwater Retarding Structure No. 50**  
**of the Mountain Run Watershed**  
**Culpeper County, Virginia**

Prepared By:  
USDA – Natural Resources Conservation Service

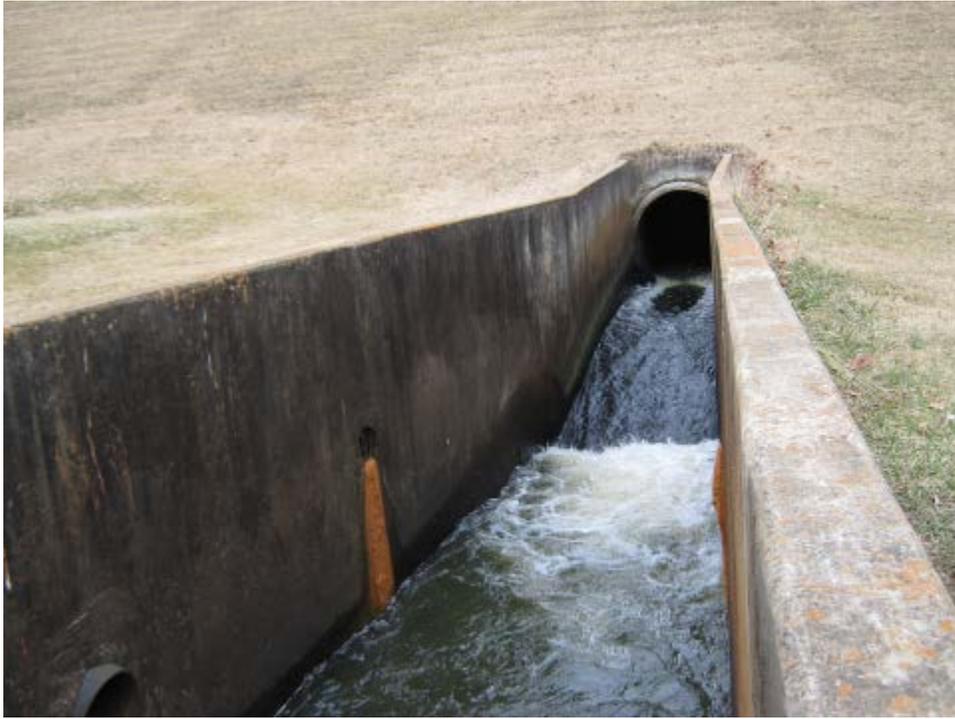
Figure 2. Principal spillway outlet pipe, chute spillway, and drains below dam.

Principal Spillway: The principal spillway is a 192-foot-long, 66-inch diameter, reinforced concrete pipe with a 16.5 foot by 5.5 foot (interior dimensions), 25.75-foot-high, reinforced concrete riser discharging into a chute spillway outlet structure. The riser controls the normal pool with two weirs, 16.5-foot-long each, at elevation 384.2 feet. A 30-inch diameter circular gate located 15 inches above the base of the riser is provided for dewatering. The outlet works, including the downstream chute spillway, are in generally good condition (Figures 2-4). A raw water line with two 18-inch diameter intakes is present in the principal spillway structure.

Internal Drain System: A trench drain was installed along a centerline located 10 feet downstream of the toe of the Zone 1 fill. Drain fill was also placed as a diaphragm surrounding the principal spillway conduit approximately 20 feet wide and extending 70 feet downstream from the centerline of the trench drain. The drain fill was graded as aggregate base material with no additional filter. Ten-inch diameter perforated collector pipes were installed. The toe drains exit through the sidewalls of the principal spillway outlet structure.

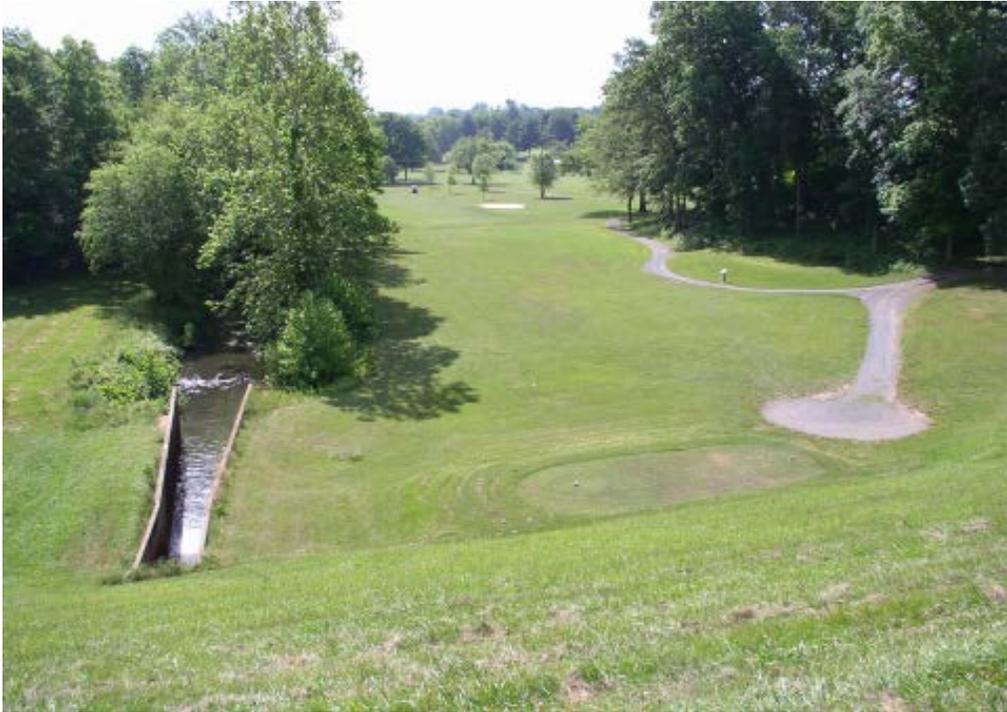
Figure 3. Looking downstream from top of dam.

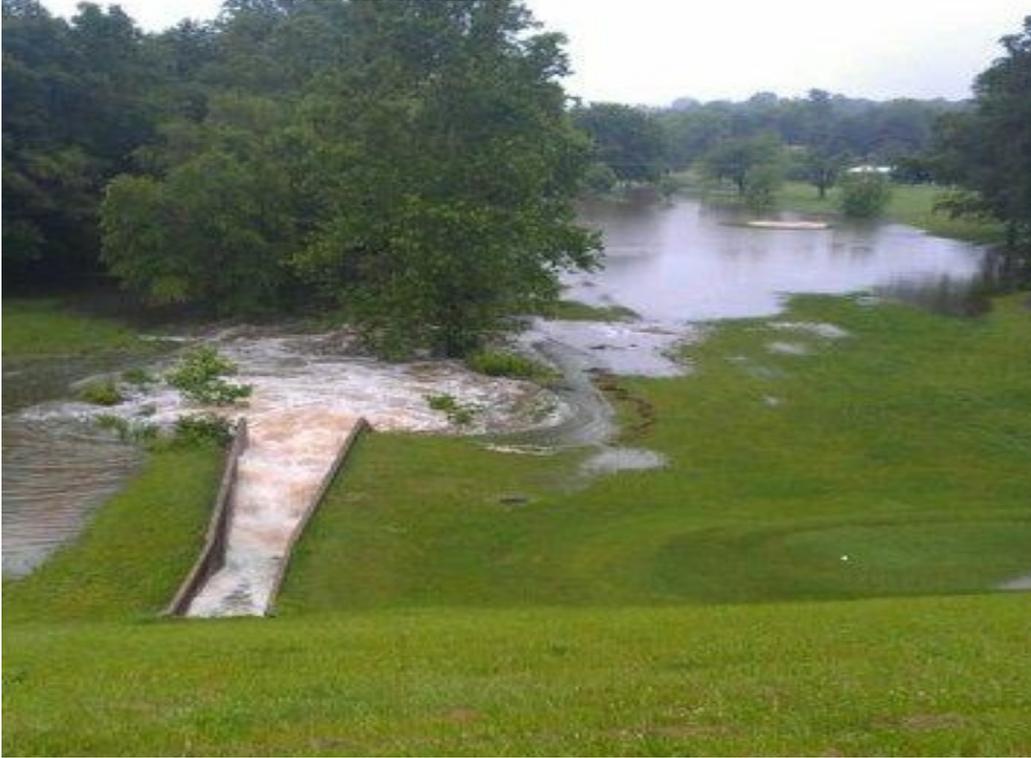
Figure 4. Looking downstream during flood event.

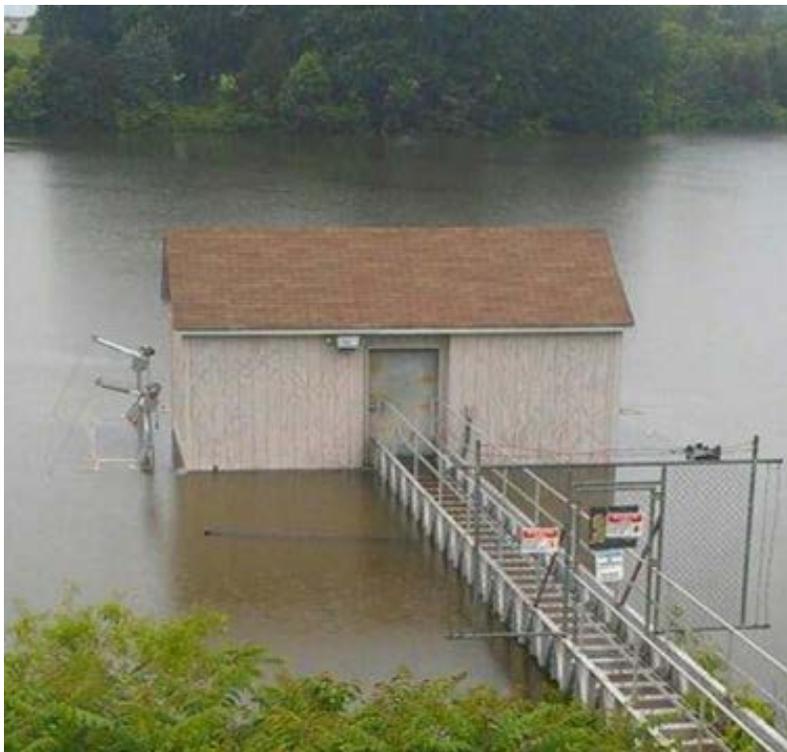
Figure 5. Water intake building during flood event.

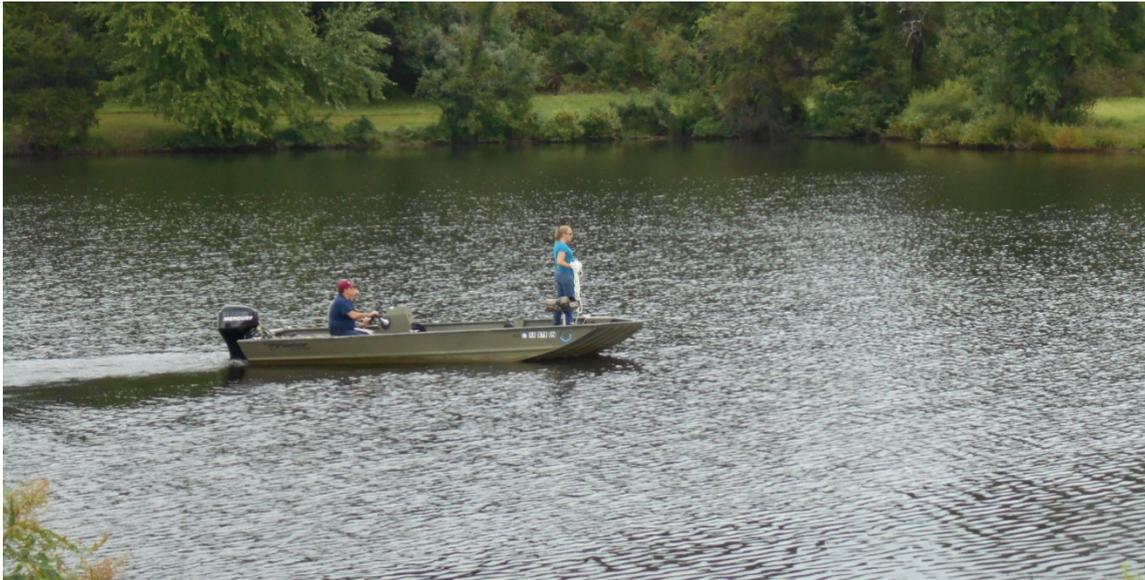
Figure 6. Sediment survey, in progress.

Sedimentation: Lake Pelham was designed to store 100 years of sediment in the pool area. The designed submerged sediment storage capacity was 877 acre-feet at a planned sediment accumulation rate of 8.77 acre-feet per year. Based upon earlier sediment studies, the original submerged sediment storage capacity was actually 962 acre-feet. The volume of submerged sediment in the pool in 2014 was 253 acre-feet. The total submerged sediment volume accumulated between 1972 and 2014 was approximately 253 acre-feet. The sedimentation rate from 1972 to 1987 was 9.02 acre-feet per year. From 1987 to 2014, the sedimentation rate was 4.2 acre-feet per year. As of 2014, the remaining capacity of the sediment pool was 709 acre-feet (Figure 6). About a third of the land cover within the watershed is forested and has not changed since the dam was constructed. The future sedimentation rate is projected to be the same as the rate for the past 27 years. In 2014, there were 169 years of submerged sediment pool life remaining.

There were 65 acre-feet of aerated sediment storage planned. Aerated sediment is sediment that is deposited above the normal pool during high flows. The designed deposition rate for the aerated sediment was 0.65 acre-feet per year. There was very little evidence of aerated sediment at Mountain Run 50 in the fall of 2014 and no visible gravel bars at the inlets to the lake. Since the average deposition rate for submerged sediment was only 65% of what was originally predicted, the deposition of aerated sediment in the flood pool should have been at a similar reduced rate. Sixty-five percent of the original predicted aerated sediment deposition rate is 0.42 acre-feet per year of aerated sediment or a total over the 42 years prior to 2014 of 17.75 acre-feet. Since the original design allowed for 65 acre-feet of aerated sediment to be deposited in the flood pool, there should be approximately 46 acre-feet of capacity for aerated sediment remaining. At 0.42 acre-feet of aerated sediment per year, there is room for over 100 more years of aerated sediment deposition.

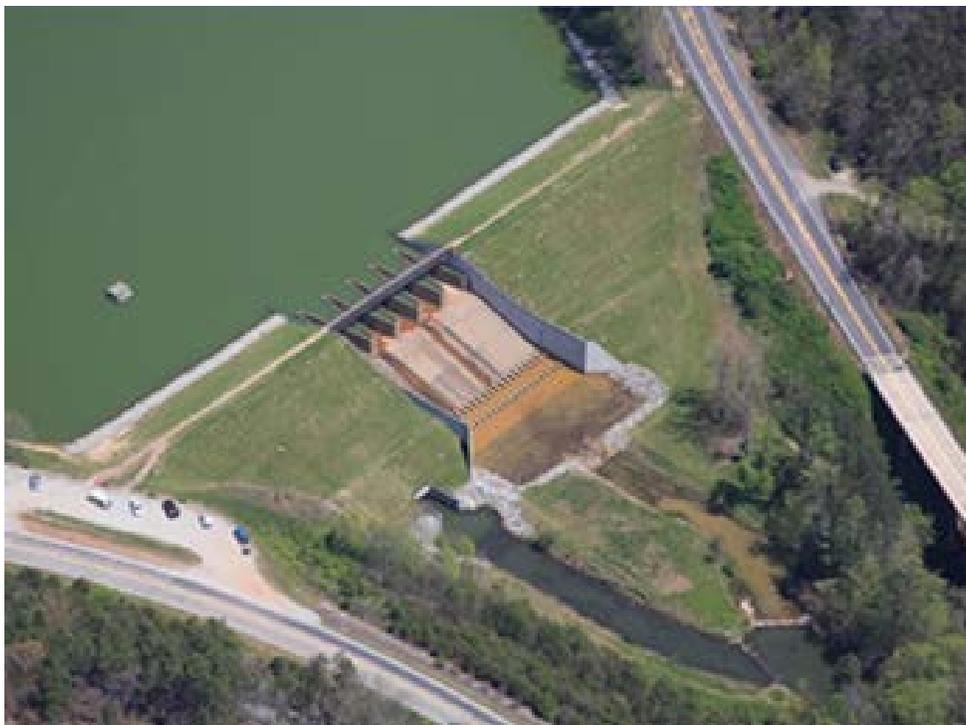
Figure 7. Example of a 5-cycle labyrinth weir.

The recommended plan is to rehabilitate Mountain Run Dam No. 50 dam to meet current Virginia Division of Dam Safety and NRCS criteria by installing a 198-foot-wide, 6-cycle structural concrete labyrinth spillway over the embankment, installing an 800-foot-long earthen berm across the existing auxiliary spillway, and upgrading the water intake structure. There will be no change in the current levels of flood protection downstream, water supply, or recreational uses of the lake as a result of project activity.

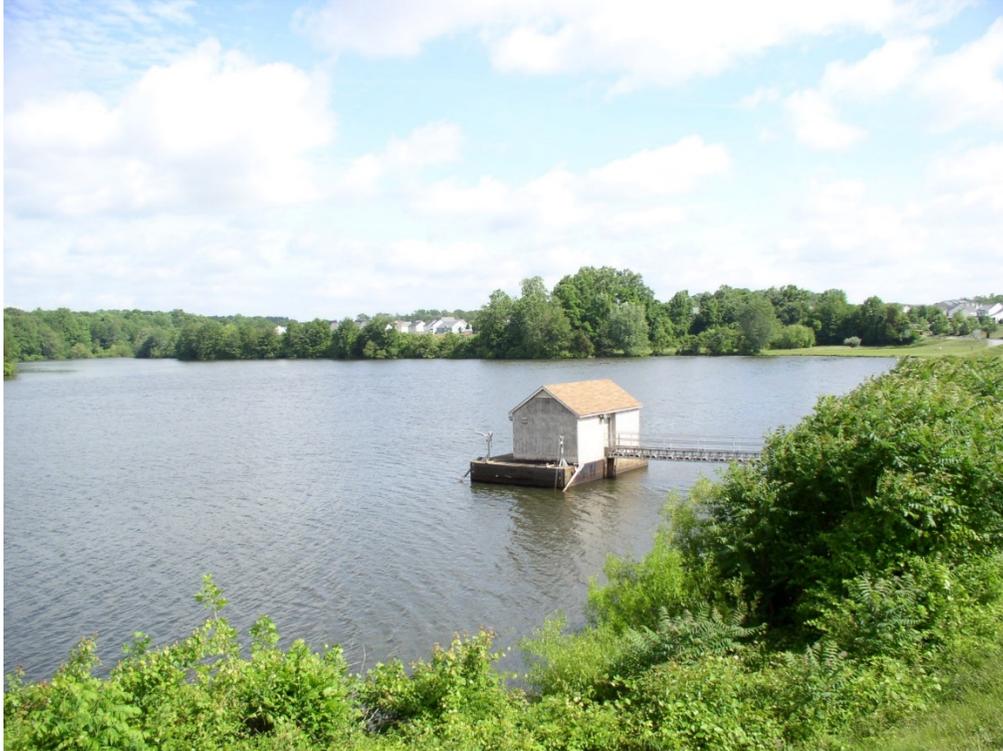
Figure 8. Riser and water intake building.

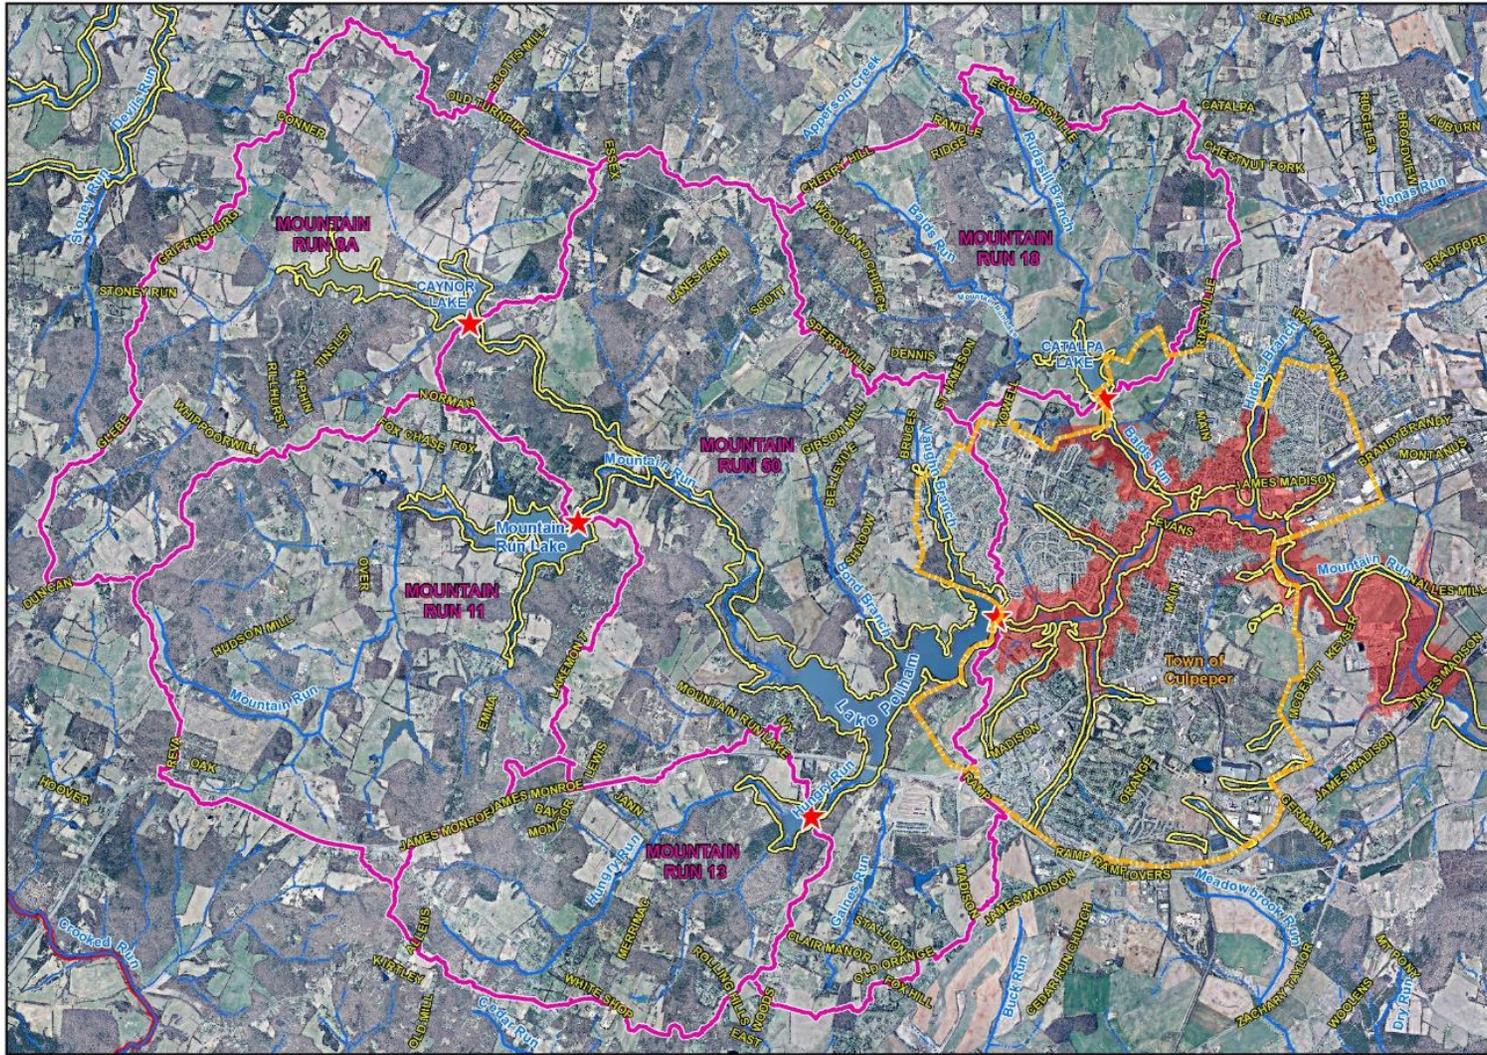
**Mountain Run 50 – Lake Pelham with Sub-Watersheds & Dam Safety Approved Breach Inundation Zone Culpeper Co., VA**

The Sponsors have current breach inundation zone maps for the dam that comply with the Virginia Impounding Structures Law and Regulations for high hazard dams. These maps show the breach inundation zone that would occur if the dam failed when the water level was at the top of the dam. The Virginia Impounding Structures Regulations requires owners of high hazard dams to provide a dam breach inundation zone map to determine hazard classification and develop the Emergency Action Plan (EAP). The purpose of an EAP is to outline appropriate actions and to designate parties responsible for those actions in the event of a potential failure of the dam. The Sponsors must update the EAP annually with assistance from local emergency response officials. The NRCS State Conservationist will ensure that a current EAP is prepared prior to initiation of construction.
