January 2015

Dam Rehabilitation Fact Sheet

Hearsthstone Lake, Upper North River Watershed

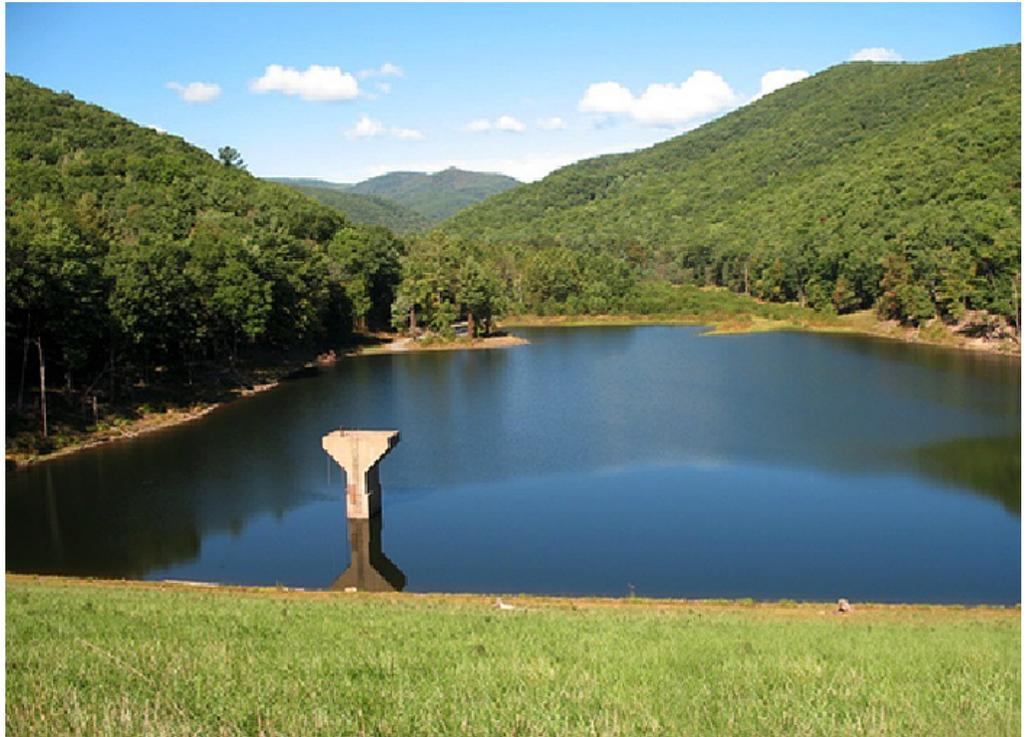
Looking upstream, this view of the Hearsthstone Lake Dam shows the pool and riser.

Flood control dams, such as Hearsthstone Lake, are designed to store floodwater during storm events and gradually release it into the stream over several days through the principal spillway pipe. This principal spillway riser and pipe regulate the daily water level in the dam and controls the rate at which the detained stormwater is released from behind the dam.

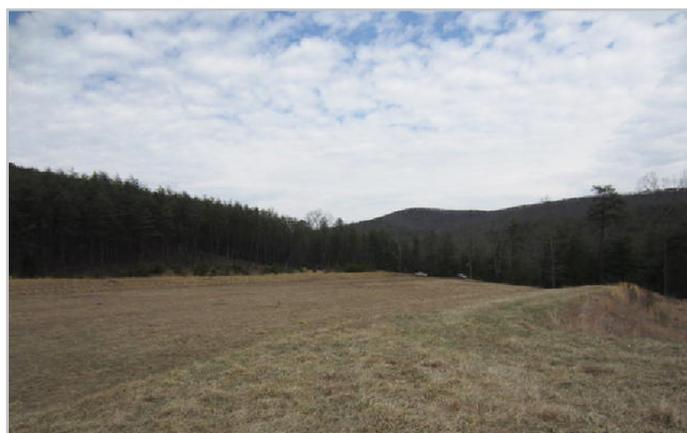
The rehabilitation project will widen the existing auxiliary spillway.

- Widening the auxiliary spillway from 250 to 342 feet. A 42-foot wide splitter dike will be installed to divide the auxiliary spillway into two bays to improve flow characteristics. The level (control) section will be moved upstream and lengthened to 70 feet.
- Raising the top of the dam 2.6 feet with earthfill and reseeding it. Raising the top of the dam and widening the auxiliary will increase its capacity enough to safely pass the flow from the Probable Maximum Precipitation storm event.
- Enhancing the stability of the vegetation in the auxiliary spillway by covering the level section and the constructed outlet with Turf Reinforcement Matting (TRM). The TRM will be covered with soil and vegetated with grass to look a lot like the existing spillway.
- Widening the footer of the concrete principal spillway riser to bring it into compliance with seismic design criteria.

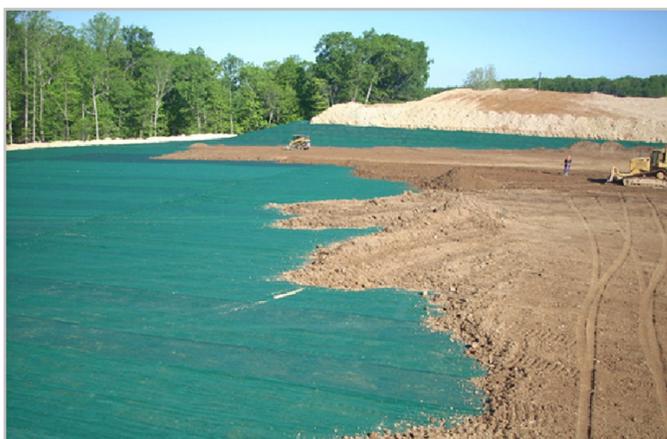
The Turf Reinforcement Matting (TRM) will not be visible after the project is completed.
